Corrosion mechanisms and behavior of a P-130x Gr/6063 A1 composite in aqueous environments

THESIS

CORROSION MECHANISMS AND BEHAVIOR OF
A P-130X GR/6063 AL
COMPOSITE IN AQUEOUS ENVIRONMENTS

September 1990

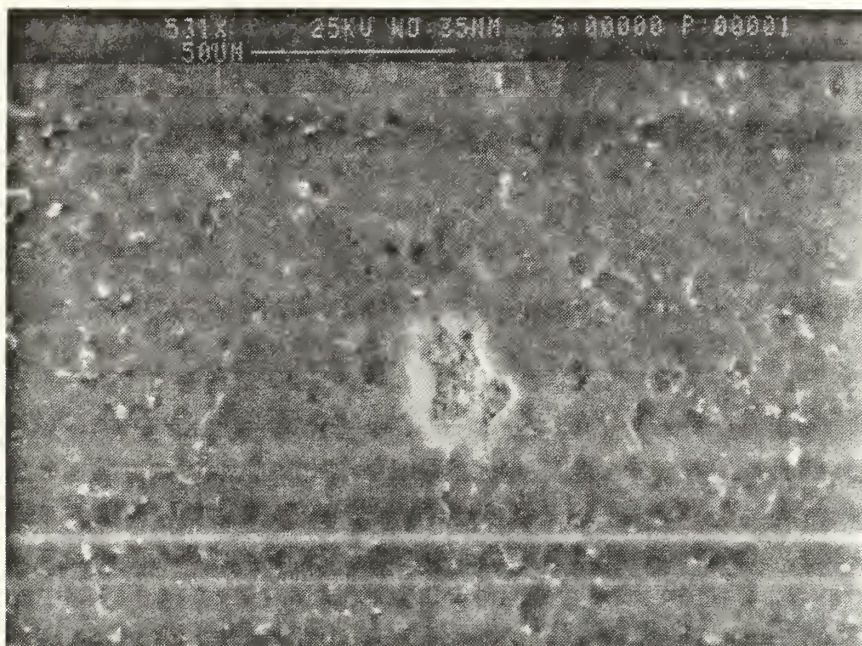
Figure 9: SEM micrograph of the edge protected sample seen in Figure 8. (531X)

The protective oxide film in the region surrounding the pit shown in Figure 9 can be seen to have a dimpled appearance. This is in contrast to the porous appearance of the oxide layer formed on the surfaces of the pits immersed in both pH 4 and pH 8 electrolytes containing no sulfite. A high magnification blow up of a region in the bottom of the pit seen in Figure 9, can be seen in Figure 10. The same crystallographic faceting can be observed in this micrograph as in the micrograph in Figure 7.
